Debris/Ice/TPS Assessment And Photographic Analysis For Shuttle Mission STS-38

February 1991

DEBRIS/ICE/TPS ASSESSMENT
AND
PHOTOGRAPHIC ANALYSIS
OF
SHUTTLE MISSION STS-38

November 15, 1990

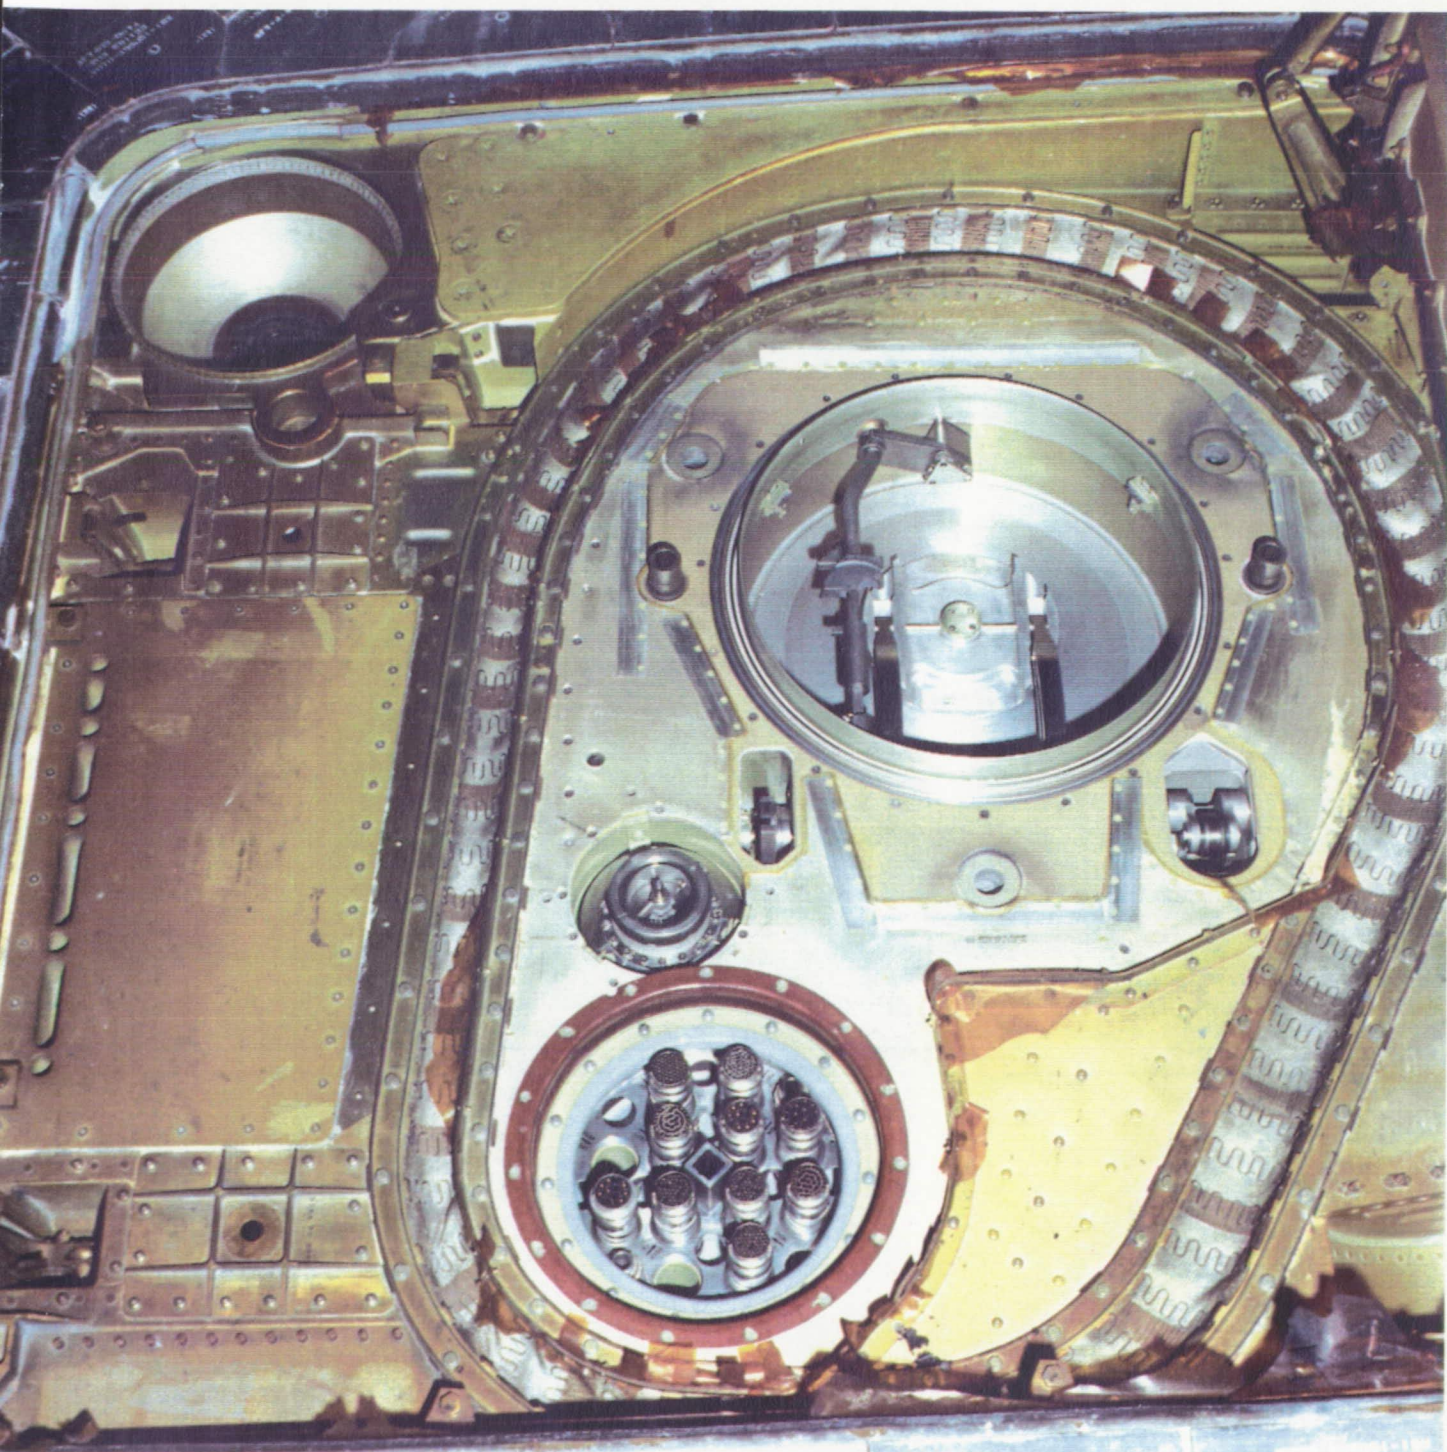
Post flight condition of the LO2 ET/ORB umbilical. The debris plunger in EO-3 was properly seated.

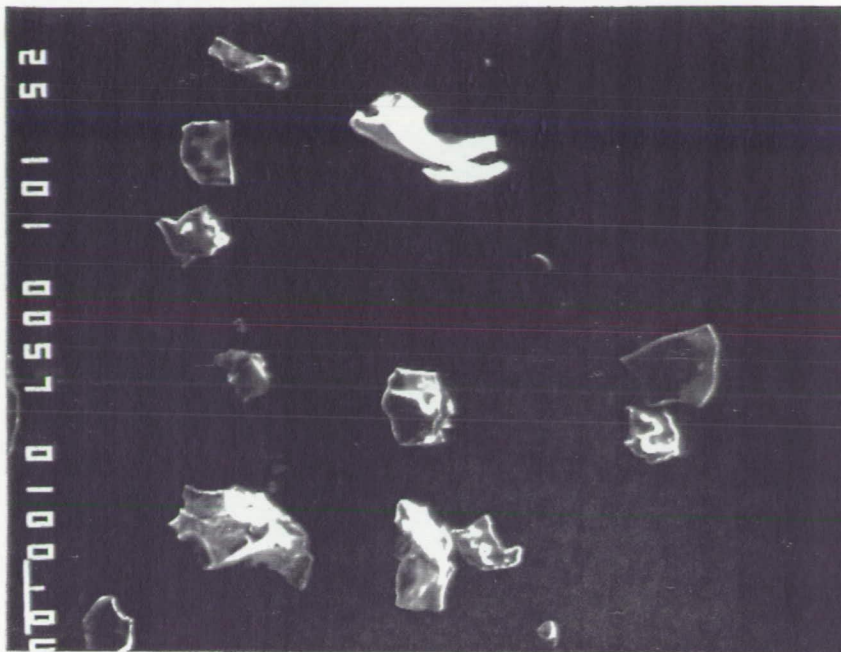
Figure 1. Low magnification SEM photomicrograph of white particles. #3, 100x.

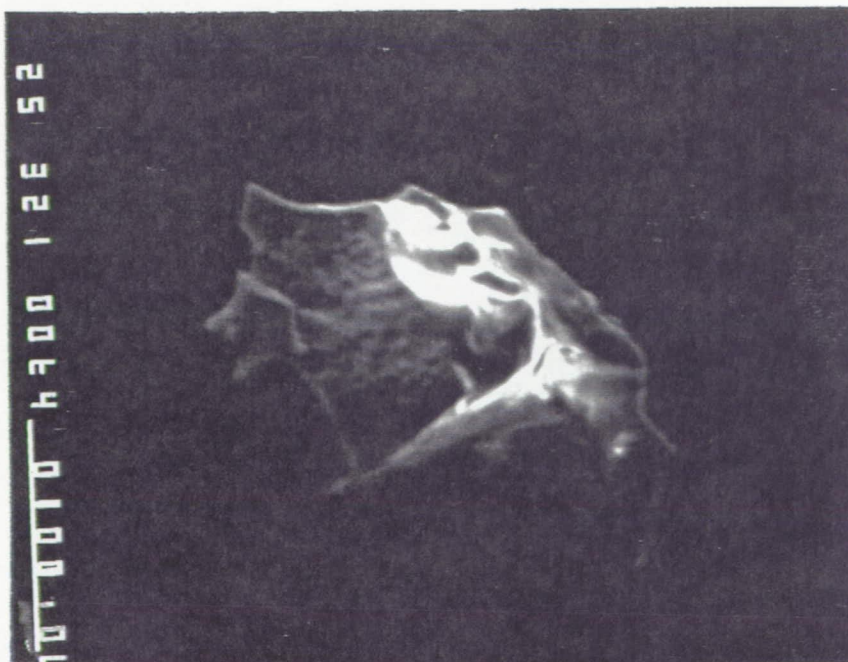
Figure 2. High magnification SEM photomicrograph of white particle from Figure 1. #3. 320x.

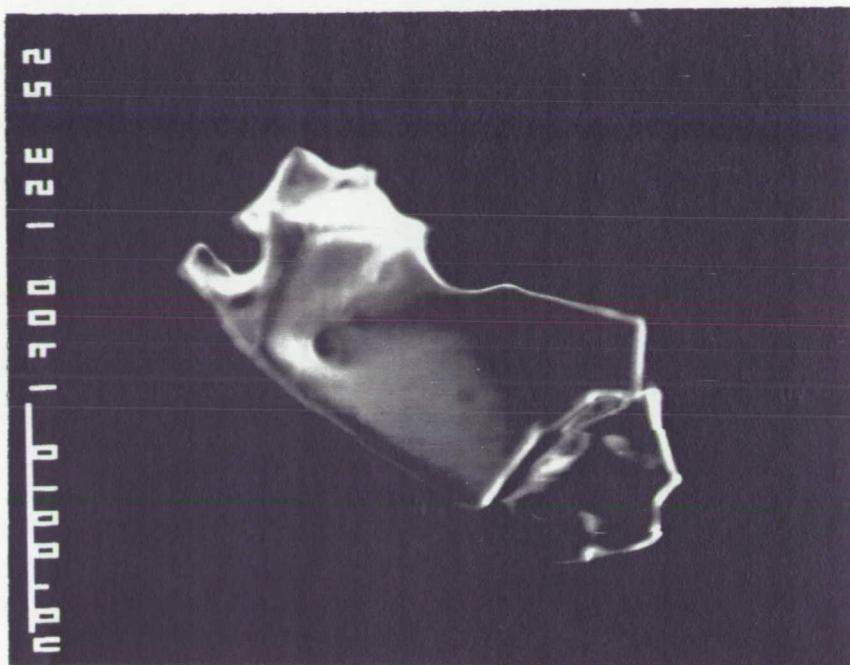
Figure 3. SEM photomicrograph of white particle from Figure 1. #3. 320x. Note the presence of the glossy surface texture.

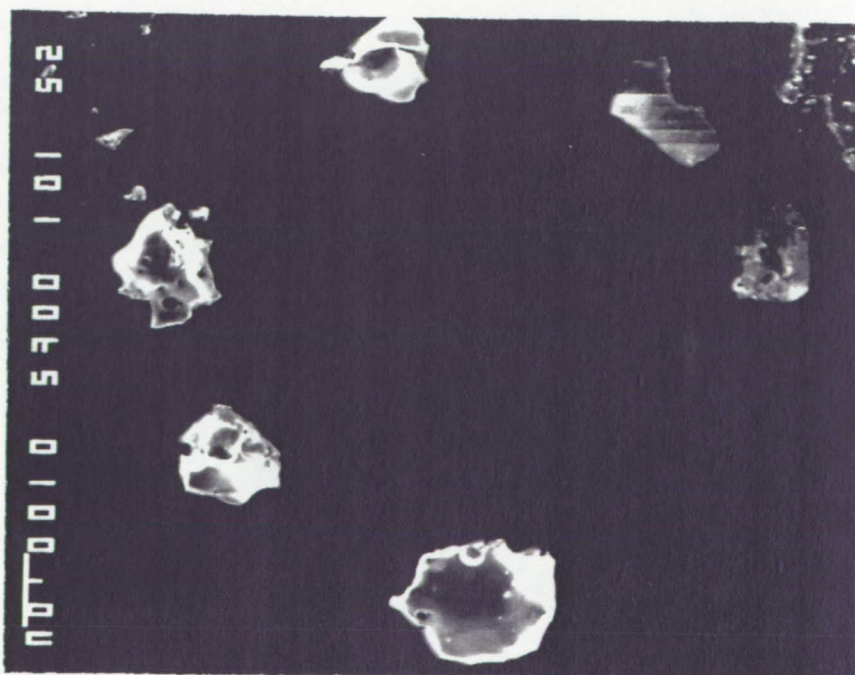
Figure 4. Low magnification SEM photomicrograph of white particles. #4. 100x.

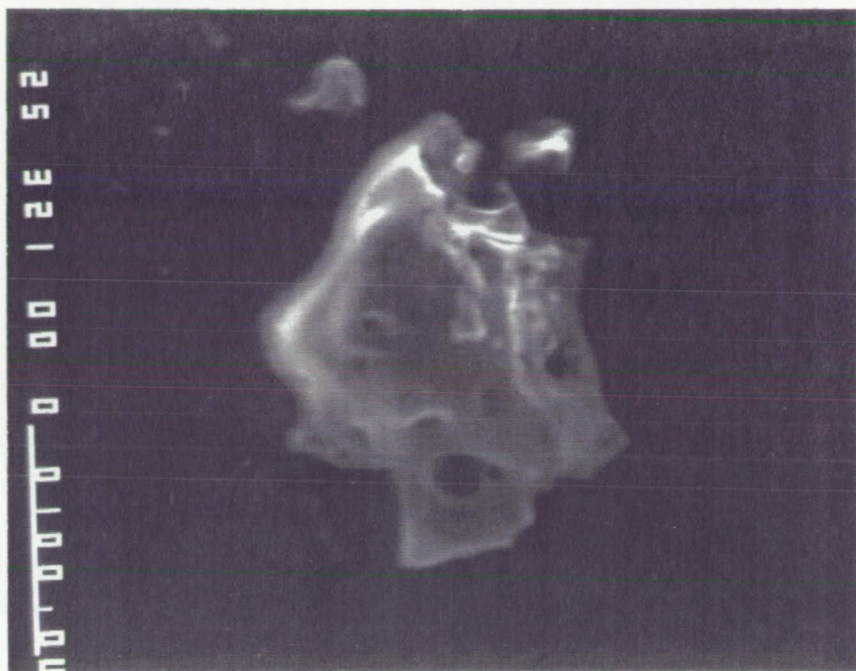
Figure 5. High magnification SEM photomicrograph of white particles to show the morphological characteristics. #4. 320x.

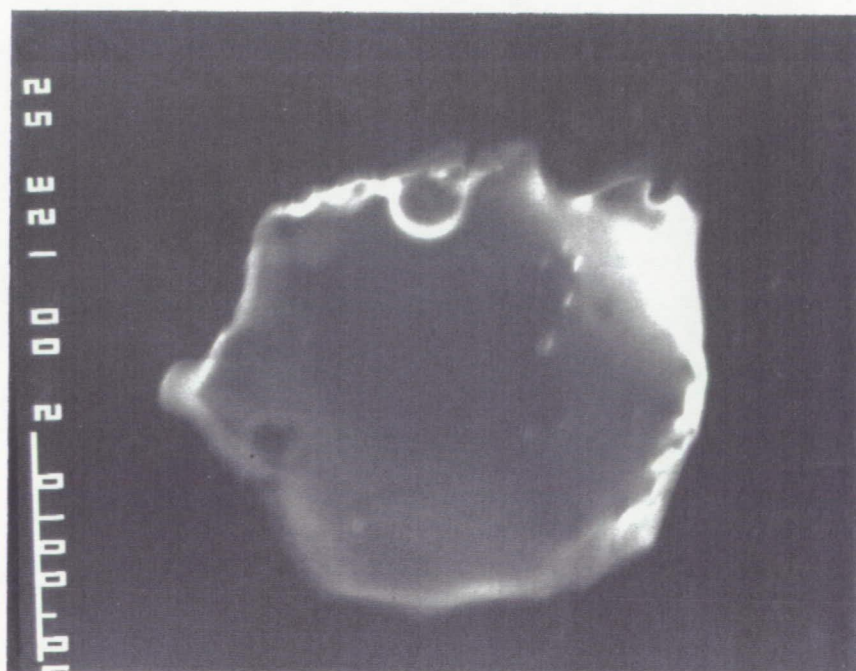
Figure 6. SEM photomicrograph of white particles. #4. 320x.

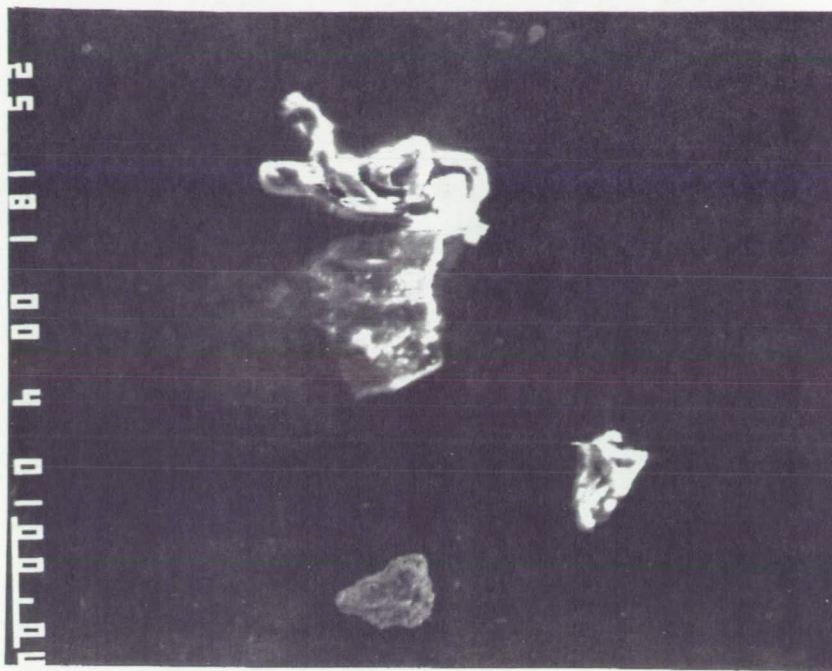
- 2.2.4 Figures 7 and 8 are low and high magnification SEM photomicrographs of Ca-Cl rich particles from sample #5. Figures 9 and 10 are SEM photomicrographs of the Zn-Si rich materials to show the pumaceous surface appearance.

Figure 7. Low magnification SEM photomicrograph of Ca-Cl rich materials. #5. 180x.

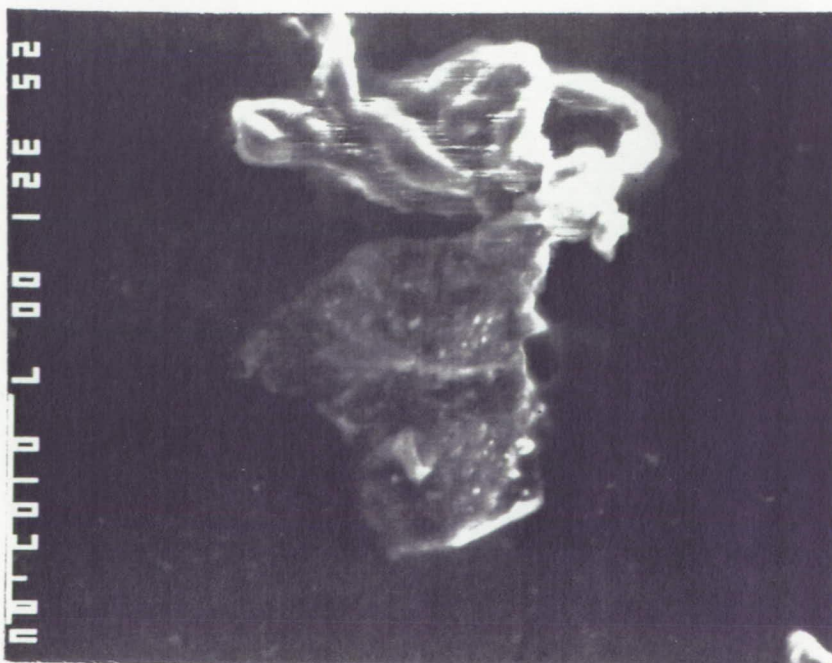
Figure 8. High magnification SEM photomicrograph of the white Ca-Cl rich materials. #5. 360x.

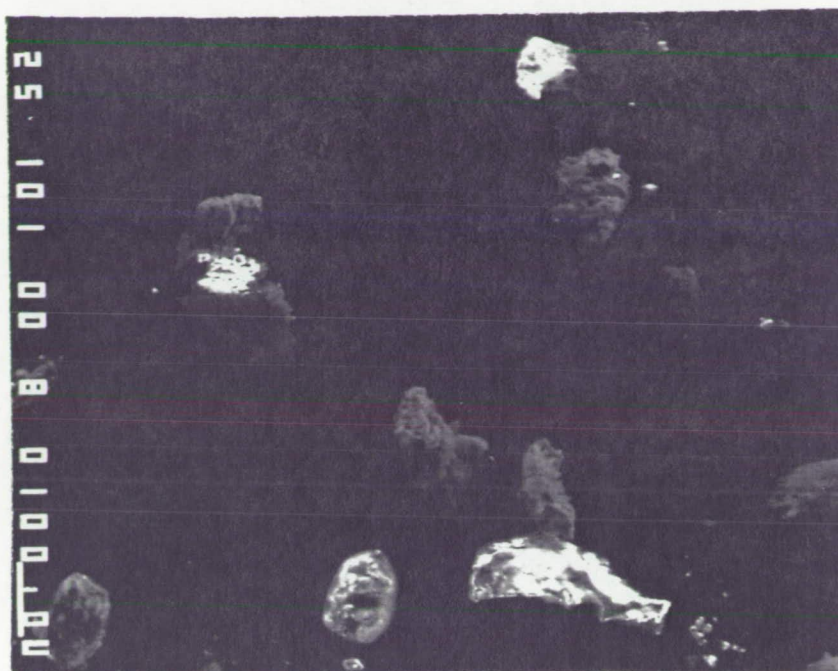
Figure 9. Low magnification SEM photomicrograph of white Zn-Si rich materials. #6. 100x.

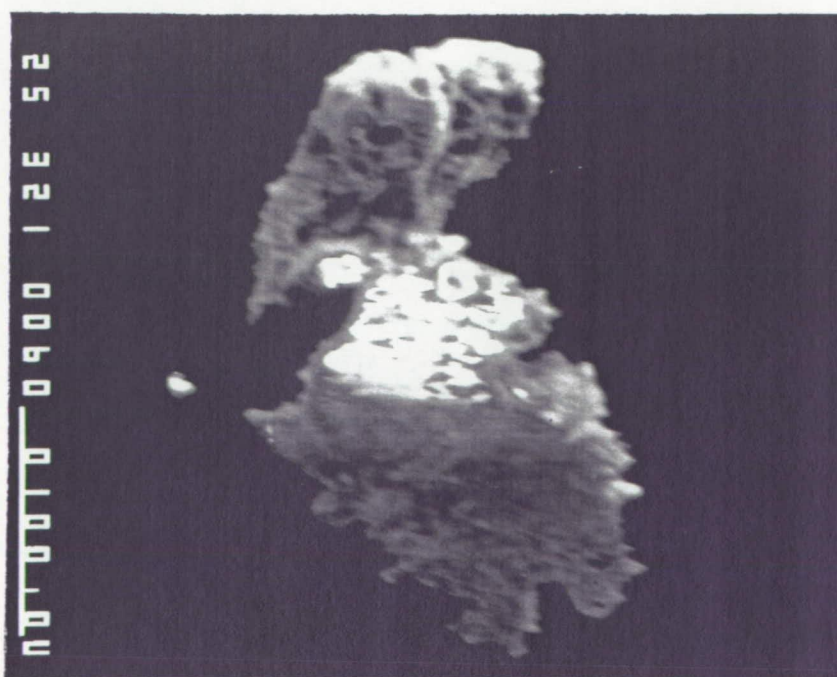
Figure 10. High magnification SEM photomicrograph of the white Zn-Si rich materials. #6. 320x. Note the pumaceous surface appearance.

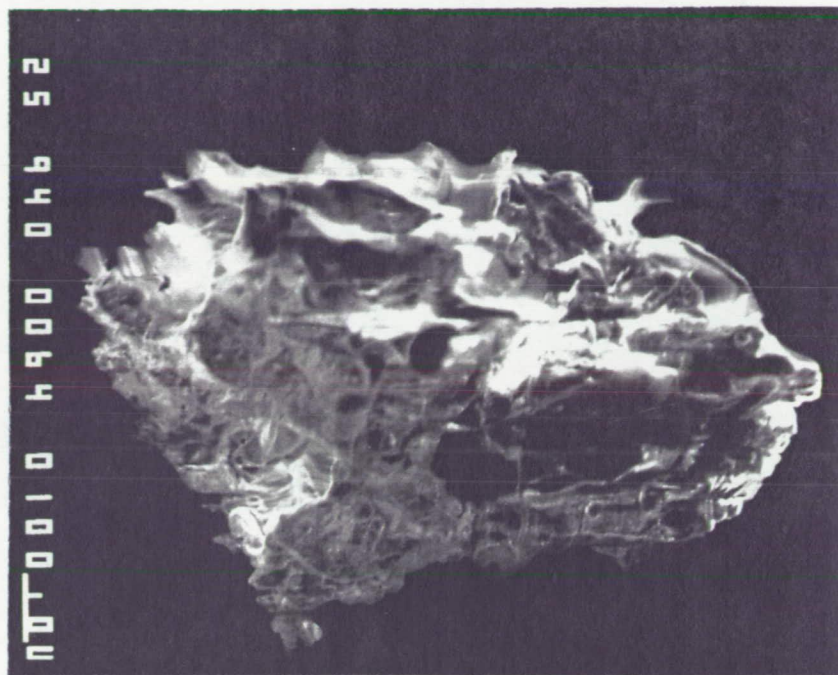
- 2.2.5 Figures 11 (#7) and 12 (#8) are low and high magnification SEM photomicrographs of black and white materials, respectively, to show the black pumaceous and fused appearance of surfaces.

- 3.3 The black pumaceous materials from sample 7 were composed of Si-rich materials. The surface of black pumaceous materials show the melted or fused appearance which might have been at high temperature during reentry (Figures 11 and 12).
- 3.4 The white materials from sample 8 were composed of Si-Al rich TPS. The fused appearance of the particle surface can be seen from Figure 12.
- 3.5 Sample 9, "Elephant hide" ensolite foam, was composed of unknown organics with calcite (CaCO_3), rutile (TiO_2), senarmontite (Sb_2O_3) and possibly SiC.
- 3.6 The EDS data suggested that the white streaks could be originated from the hypalon paints.

Figure 11. Low magnification SEM photomicrograph of the black pumaceous Si rich materials. #7. 94x.

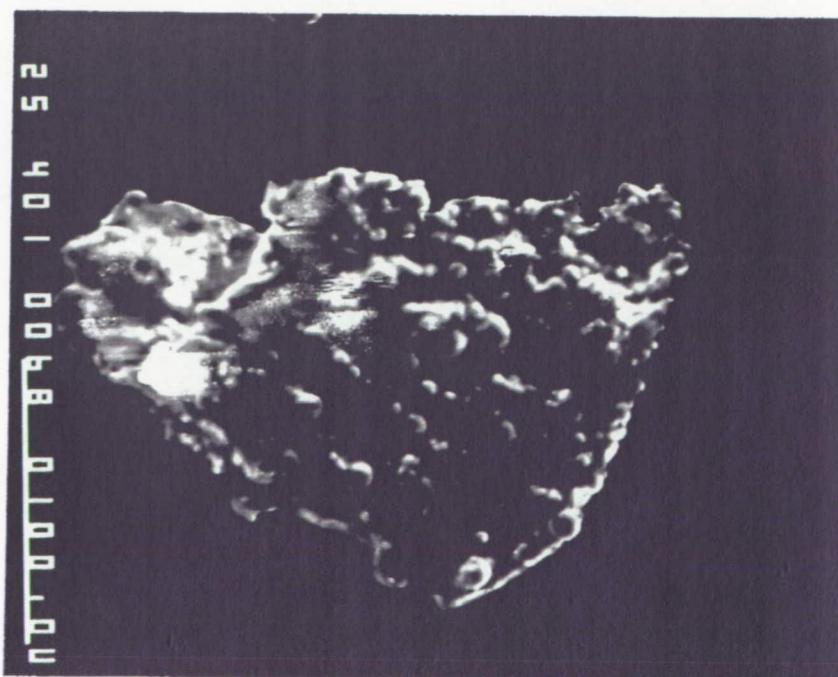
Figure 12. High magnification SEM photomicrograph of white particles. #8. 400x. Note the fused surface appearance.
